**Preliminary Tree Survey and  
Arboricultural Impact  
Assessment –  
7-11 King William Street,  
Bayswater**

FEBRUARY 2026

**Date inspected:** 9<sup>th</sup> of February 2026

**Location:** 7-11 King William Street, Bayswater

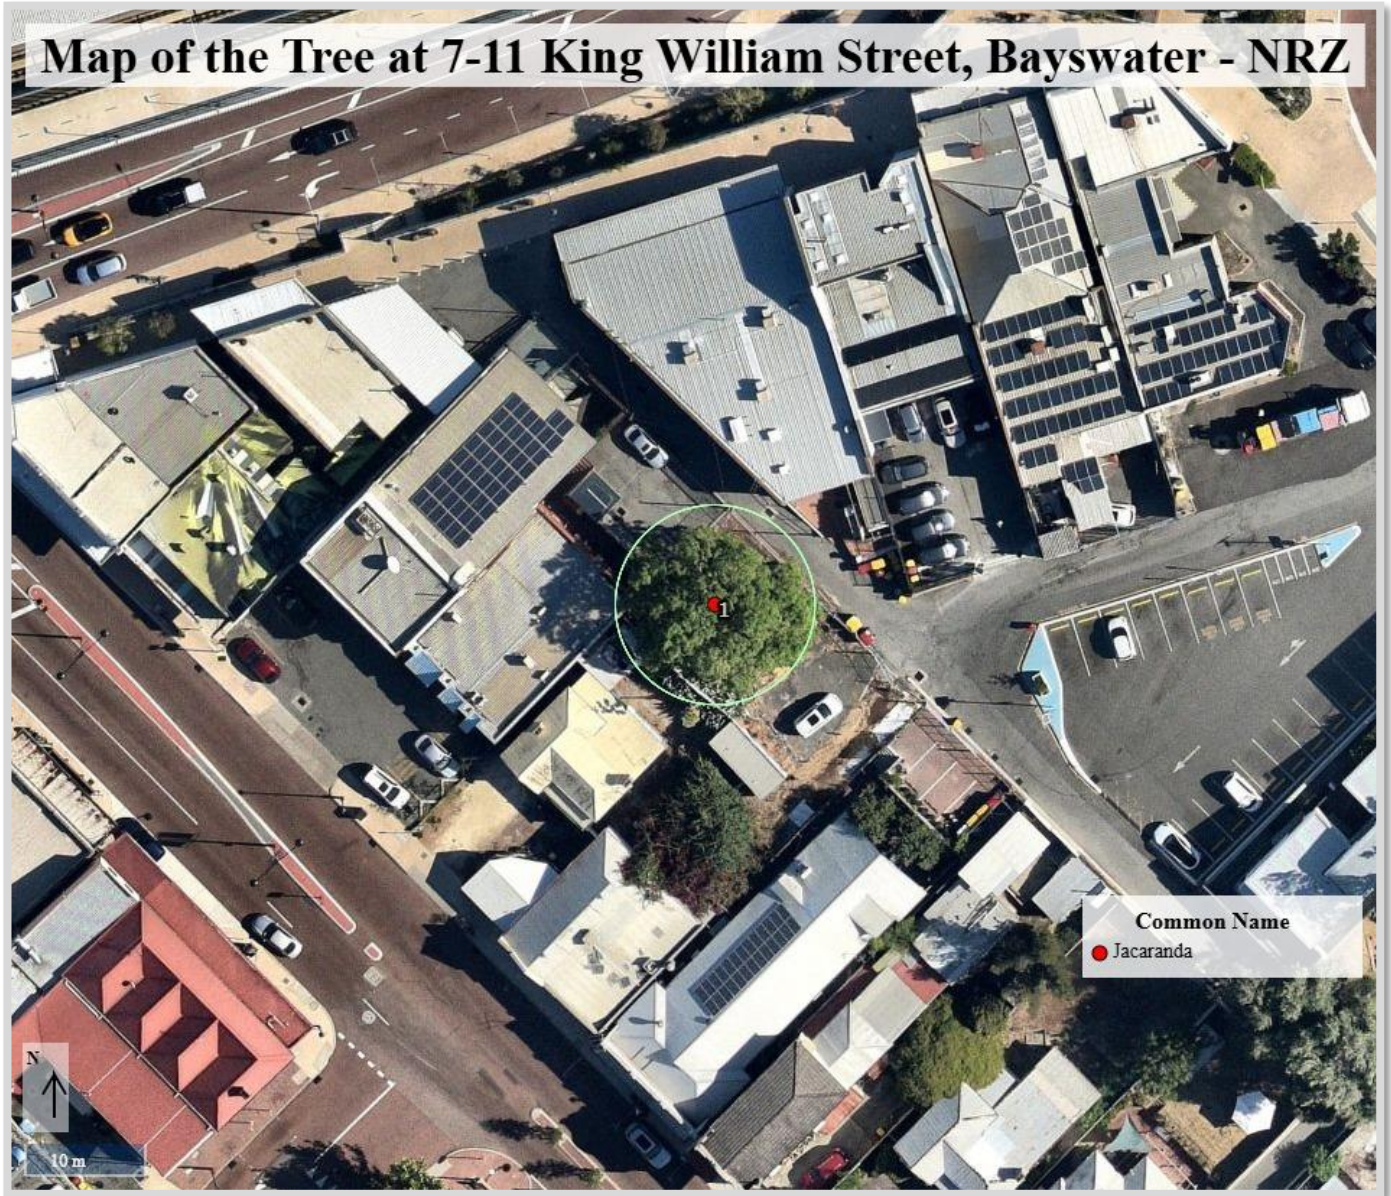
Figure 1: Displays the tree and its location with the Notional Root Zone (NRZ) radius overlay.

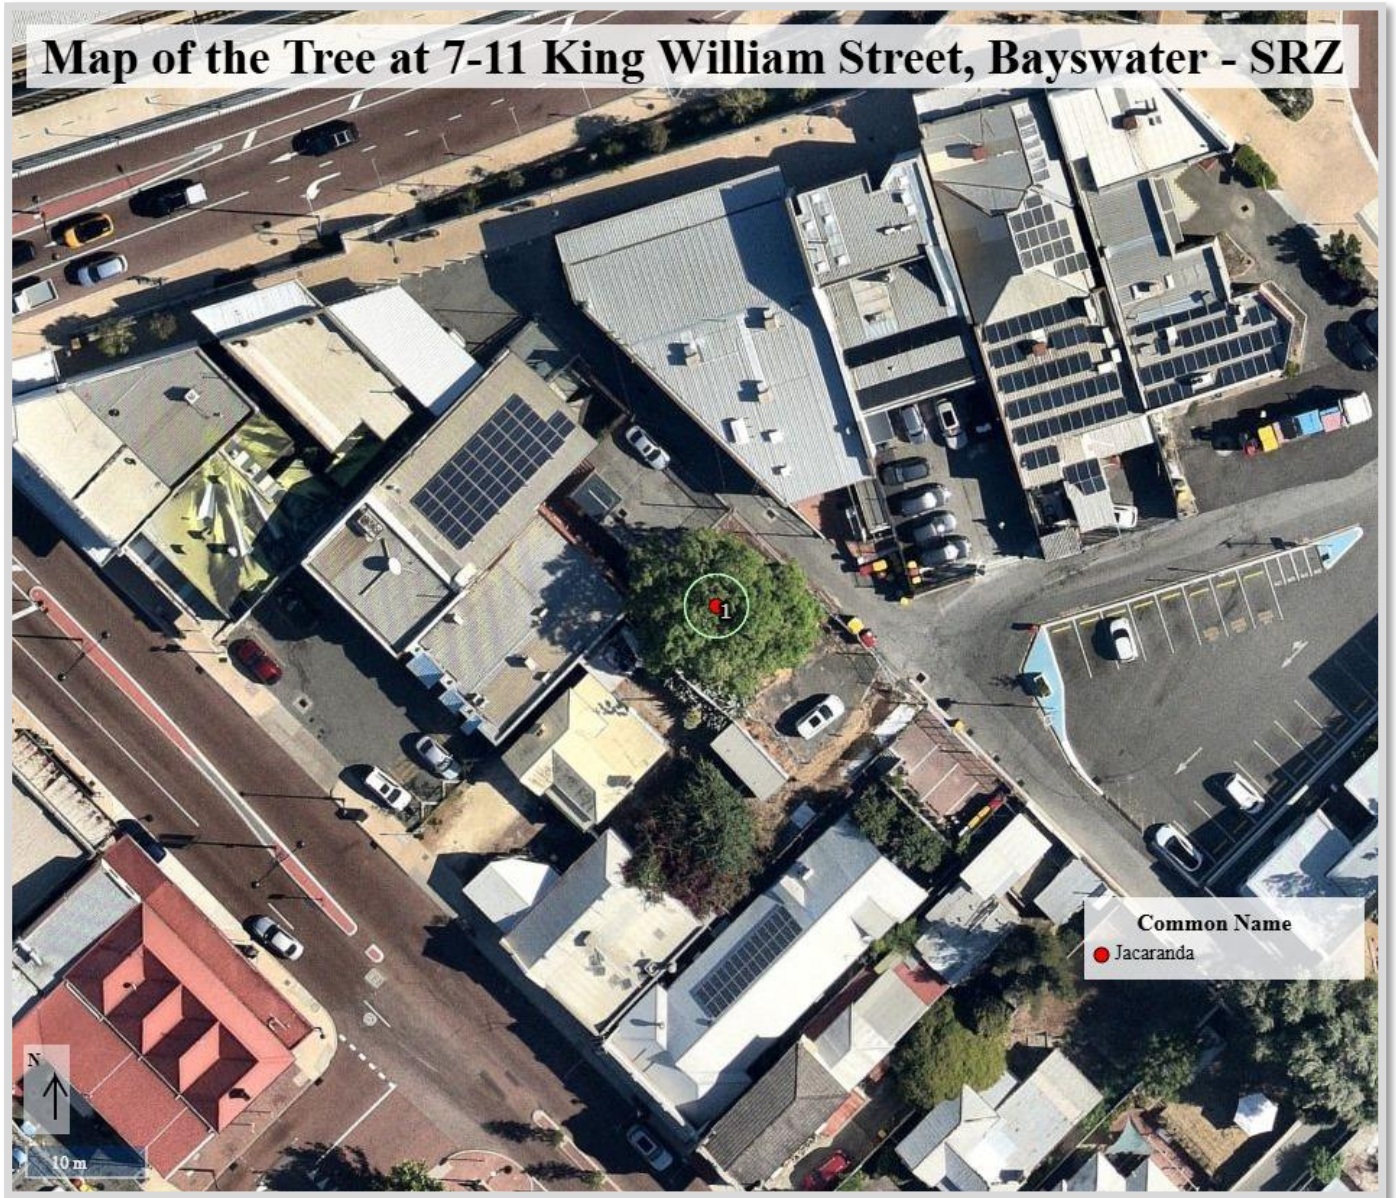
Figure 2: Displays the tree and its location with the Structural Root Zone (SRZ) radius overlay.

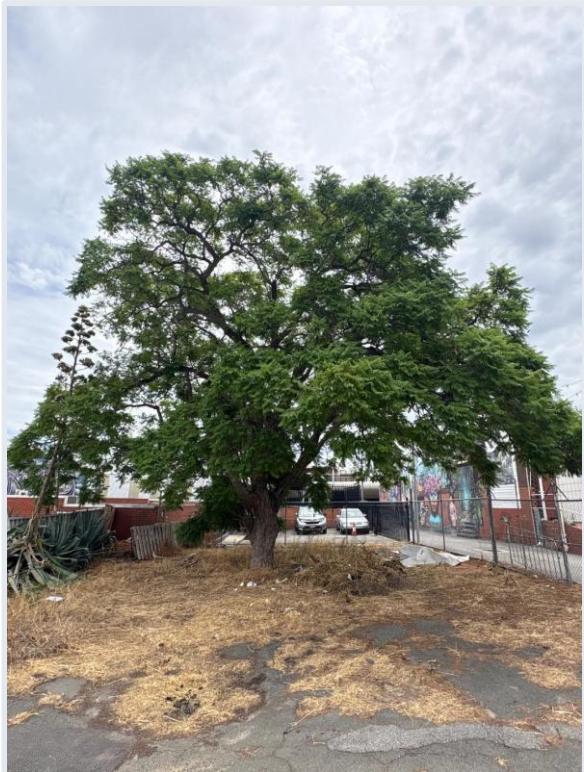
Jacaranda Tree ID #1		Photos	Street View	Map View
<b>Tree Details</b>

<p>09/02/2026</p>		
Latin Name:	Jacaranda mimosifolia			
Latitude:	-31.91892443056			
Longitude:	115.91267950975			
Tree Height (Estimated) [m]:	12.9			
Canopy Spread [m]:	17			
DSH [cm]:	73			
Health:	Good			
Structure:	Fair			
Problems:	Deadwood minor <50, Epicormic growth, Multi Crown leaders			
Notes:				
Priority:	Not applicable			
Tree Work:	No Works			
Observation Comments:				
Notional Root Zone (NRZ) [m]:	8.76			
Structural Root Zone (SRZ) [m]:	2.78			
Useful Life Expectancy:	20-40 years			
Retention Value:	High

- The tree was found to be in good health and structural condition. Minor dead wood within the crown is not considered a size or weight to represent a hazard to surrounding targets. Epicormic growth developing on the trunk from an old pruning wound and in the canopy appears soundly attached at this time. The extended second and third order branches were found to remain soundly attached with no evidence of cracking, splitting or separation.
- The tree has a Useful Life expectancy of between 20 - 40+ years and is of high retention value to the area.
- Heritage information was sourced from the WA heritage register (inHERIT) and there was no record of any Significant Trees at this location.
- This tree is not on the City of Bayswater Significant Tree Register.

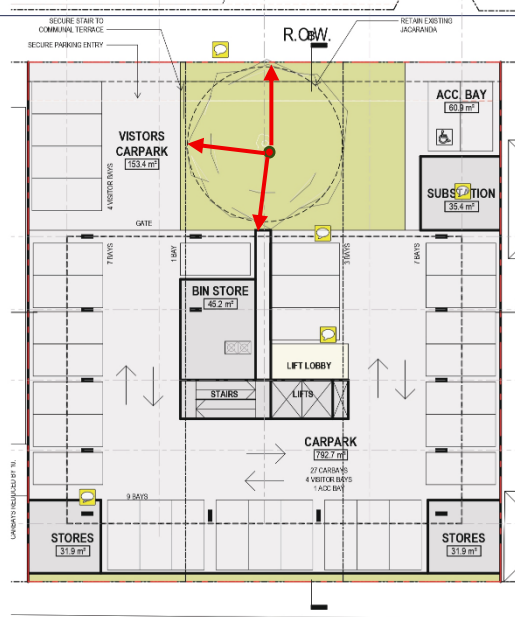
- 6.3. Existing soil levels to the north, west and east of the subject tree are not anticipated to be altered as part of the proposed works
- 6.4. The tree is 6 metres away from the visitor's car park, the laneway and the apartment block side of the tree (Figure 3).

Figure 3: Displays the position of the tree relative to the surround construction works and the distance from the base of the trunk to the proposed works of 6 metres in each direction.

The proposed apartment block will be 6 metres from the base of the tree. The Notional Root Zone (NRZ) for this tree is 8.76 metres radius from the centre of the trunk, and the Structural Root Zone (SRZ) is a radius of 2.78 metres.

Although the proposed works are within the trees NRZ, the tree is retained with an existing wall, and the root system is unlikely to extend passed the wall.

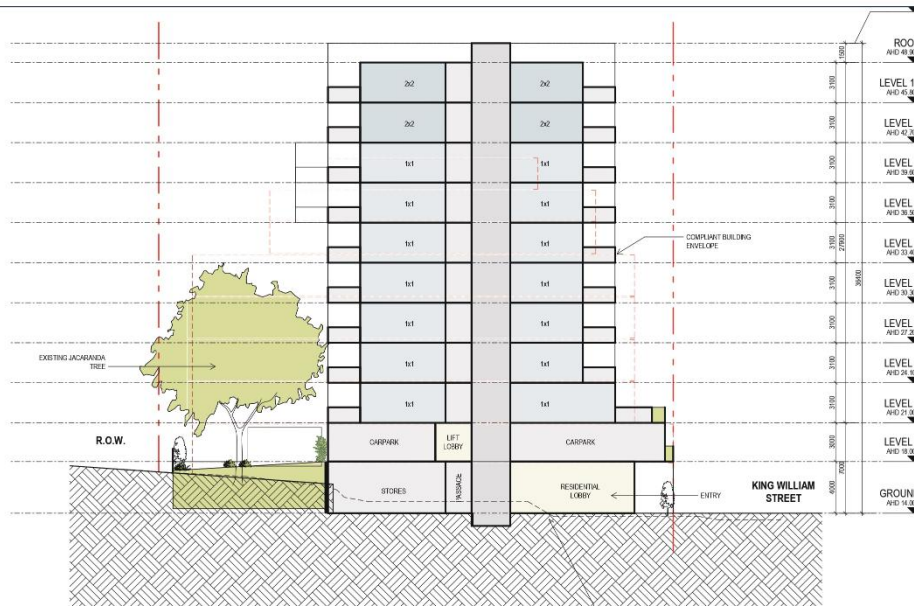
- 6.1. The proposed development comprises the construction of a mixed-use ten-storey apartment building (Figure 4).
- 6.2. The proposed building will be located to the south of the subject tree. As a result, the tree is not expected to be adversely affected by shading impacts associated with the development (Figure 4).

Figure 4: Displays the tree on the northern side of the proposed building.

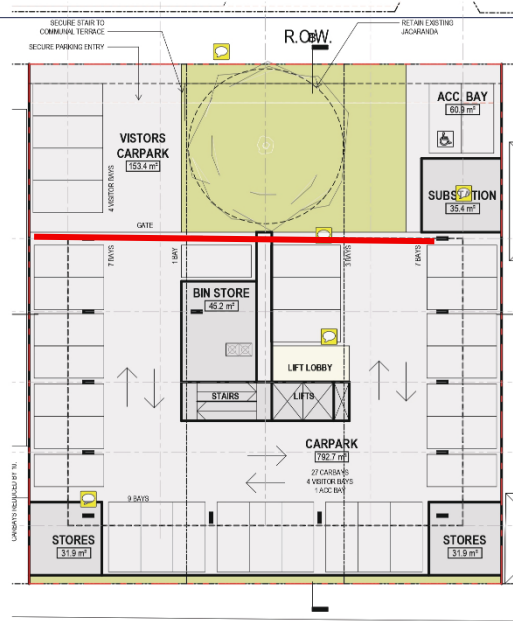
- 6.5. There is a retaining wall approximately 1 metre high on the southern side of the tree (Figure 5 and 6). This wall will be replaced as part of the construction, however, will remain in the same position.

Figure 5: Displays the line of the existing retaining wall approximately 1 metre high

When the wall is removed, any exposed roots should be inspected by Paperbark to determine their extent and potential impact if removed.

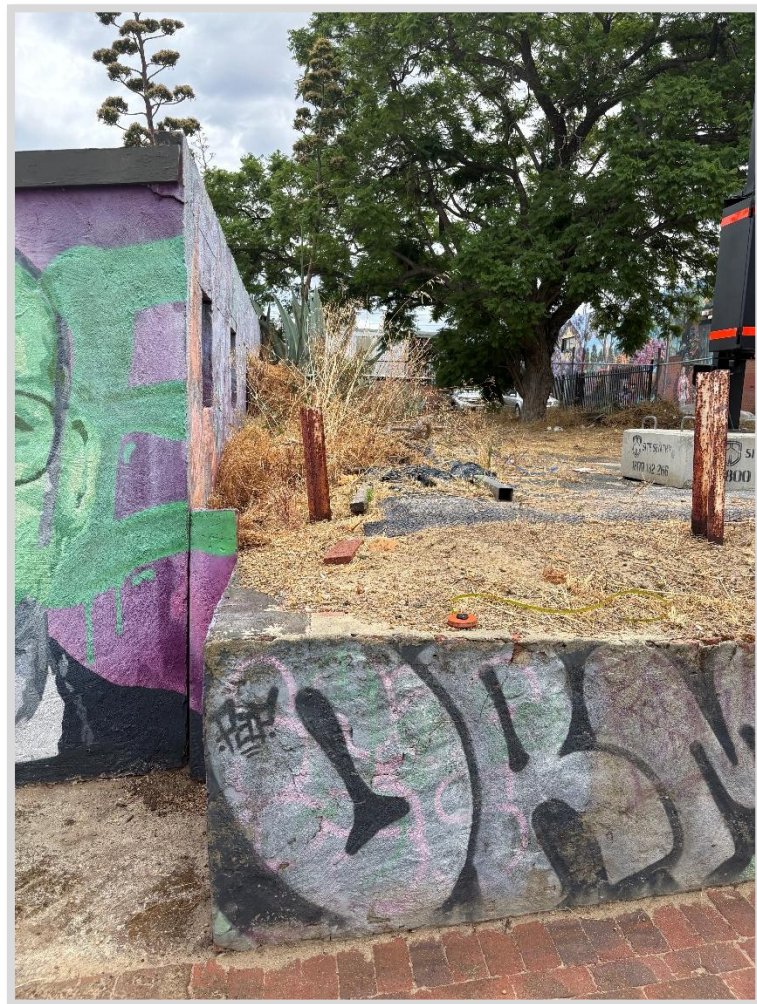
*Figure 6: Displays the retaining wall from the side which is a height of 1 metre.*

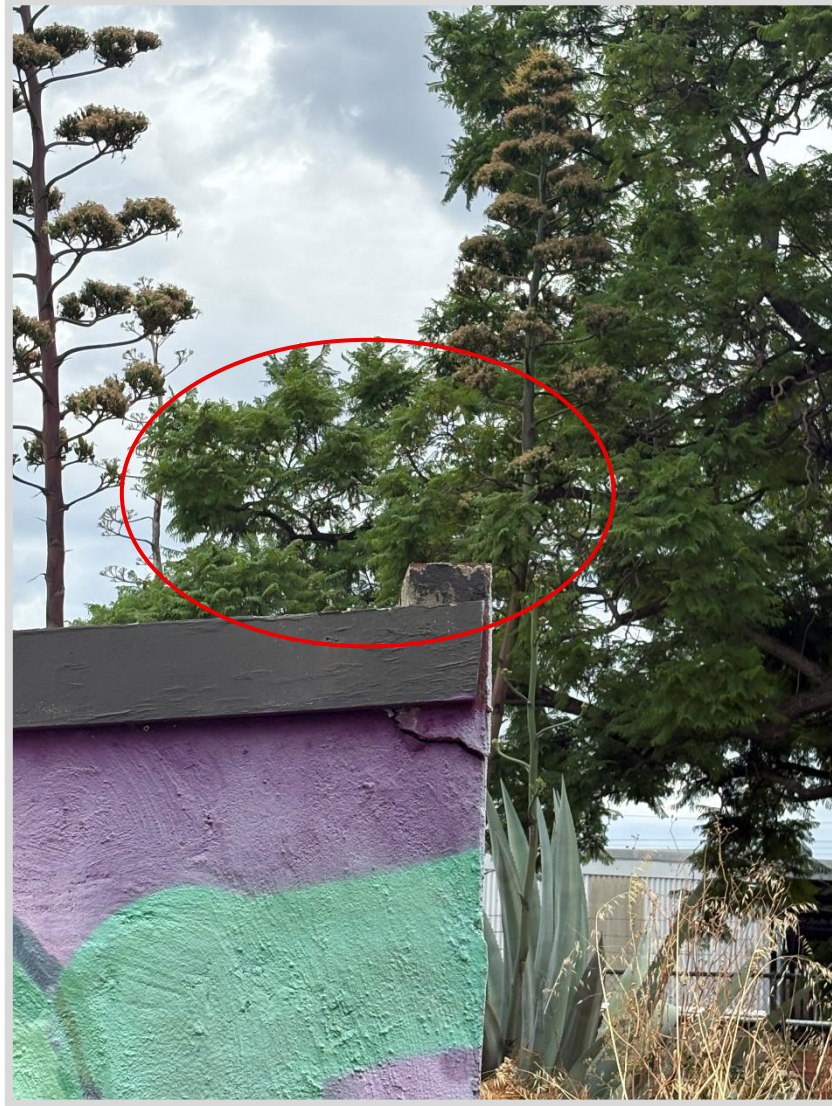
- 6.6. Minor pruning of foliage on the southern side of the canopy will be required to achieve building clearance at the first storey level. All pruning works shall be undertaken in accordance with AS 4373–2007 Pruning of Amenity Trees. (Figure 7).

*Figure 7: Displays the foliage overhanging the new building line that will require pruning to sound growth points.*

Two of the lowest southern limbs will require pruning to allow for the building as per Figure 7.

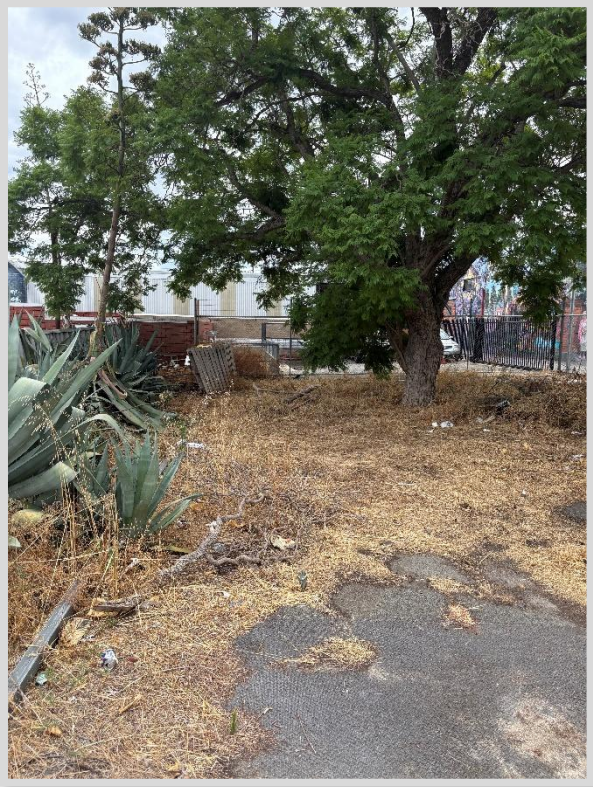
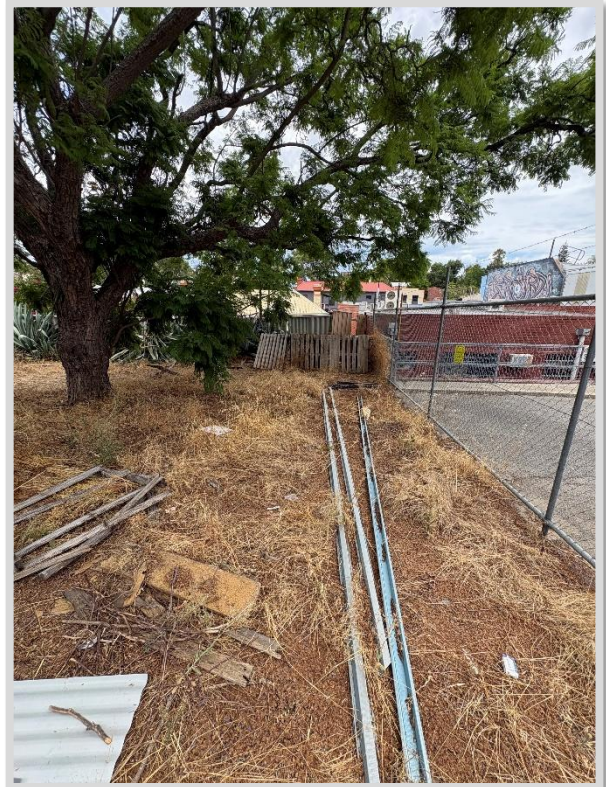
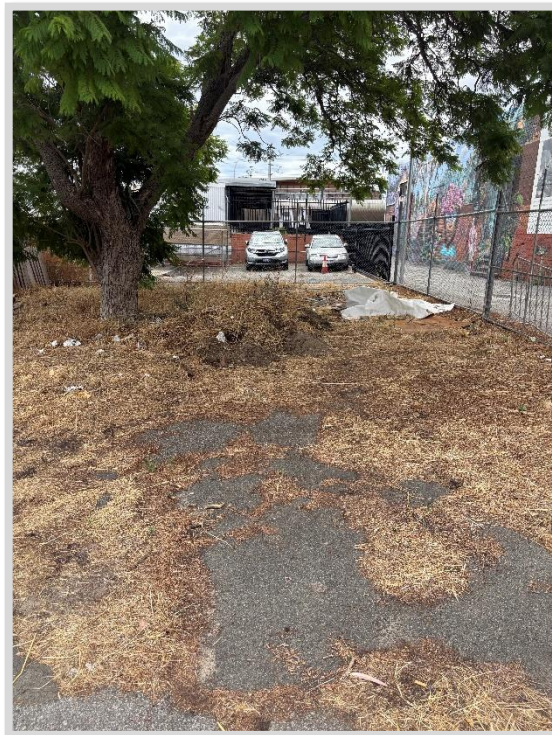
*Figure 8-10: Display the distance from the trunk of the tree (6 metres) on the three sides of the tree.*
