# Heritage Impact Statement

## King William Street

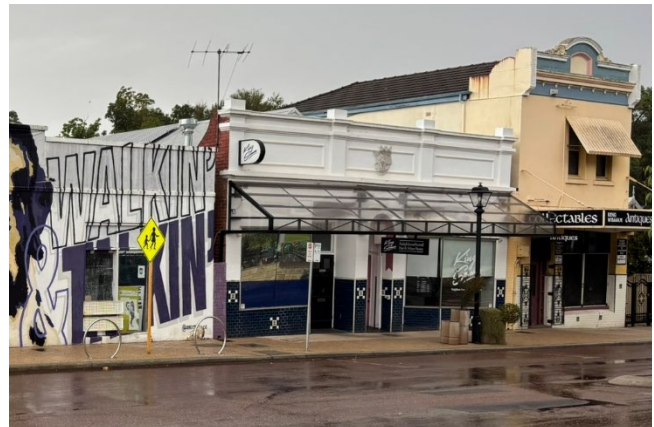
Figure 3 existing condition of neighbouring contributory heritage building no13 & 15 King William Street located east of the subject site.

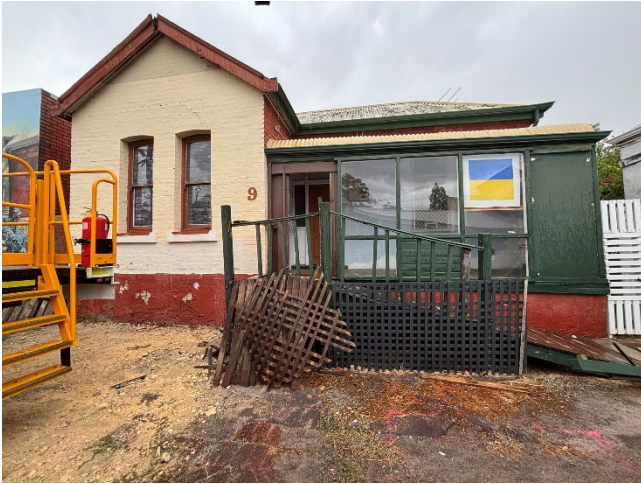
Figure 4 9 King William Street existing condition of south elevation  
Source: Urbis 2026

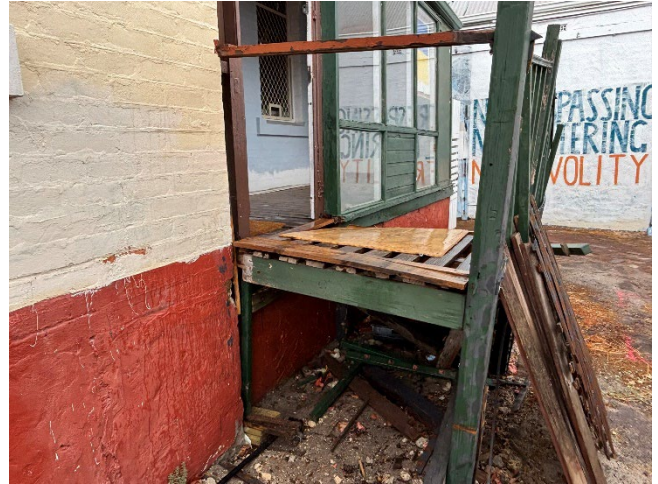
Figure 5 9 King William Street poor condition of entry ramp to verandah  
Source: Urbis 2026

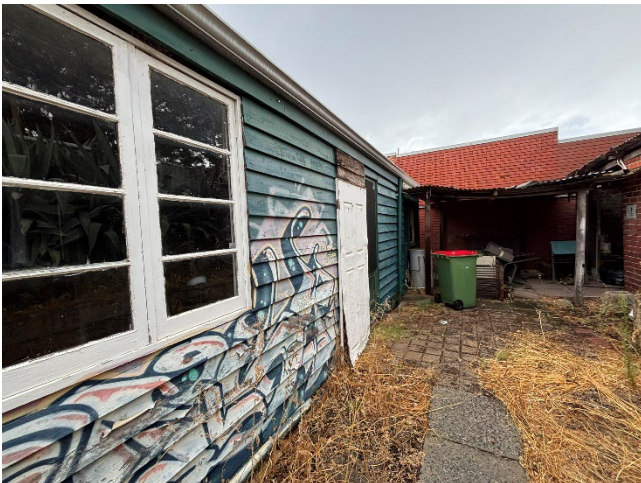
Figure 6 North (rear) elevation of 9 King William Street  
Source: Urbis 2026

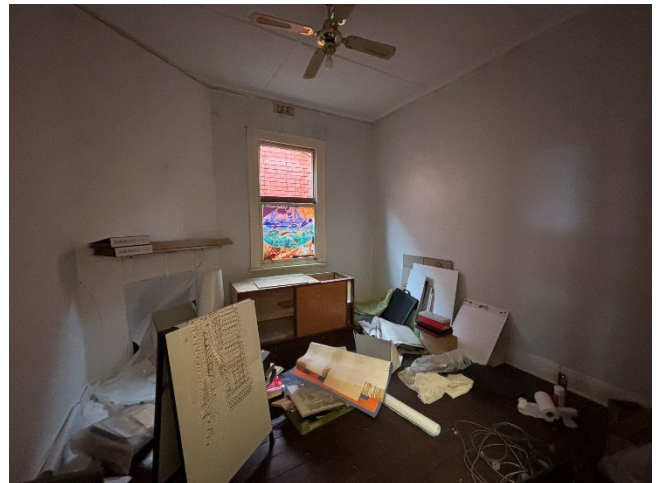
Figure 7 Interior condition of 9 King William Street  
Source: Urbis 2026

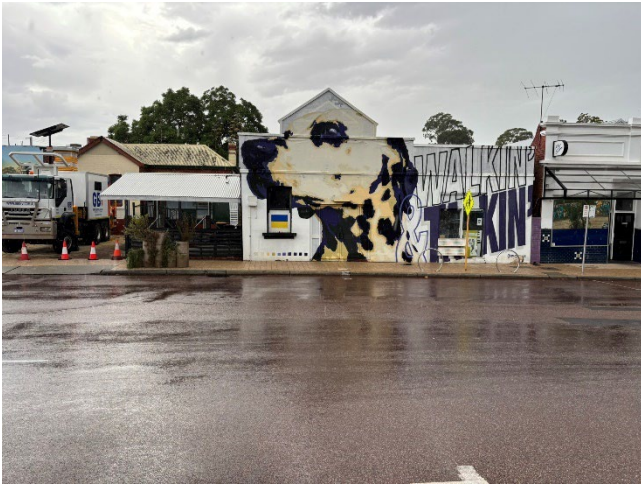
Figure 8 11 King William Street existing condition of south elevation  
Source: Urbis 2026

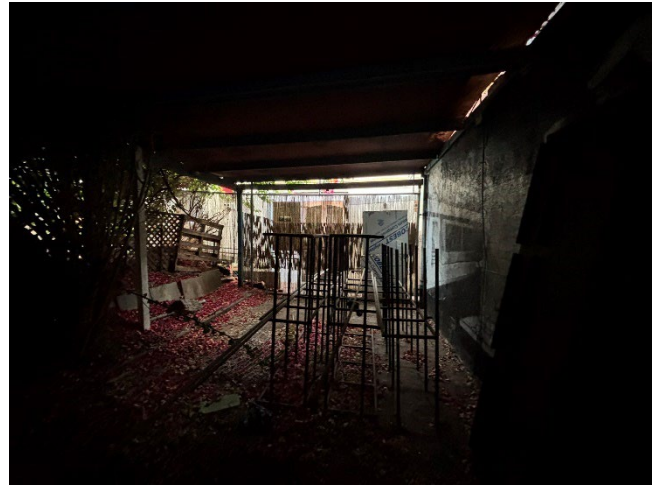
Figure 9 11 King William Street north (rear) elevation with shelter structure and overgrown gardens.  
Source: Urbis 2026

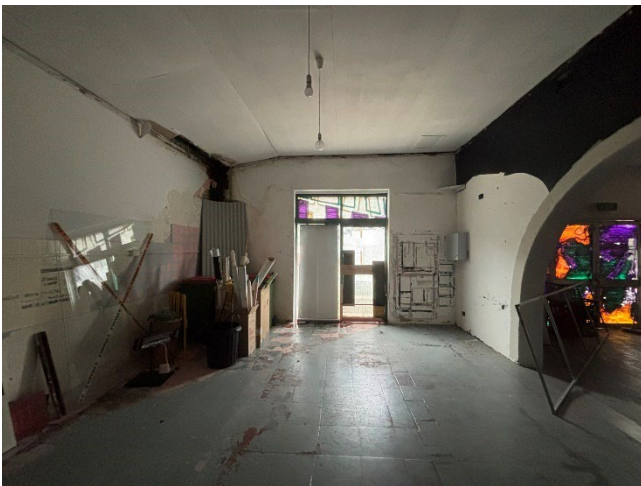
Figure 10 11 King Willim Street intrior condition substantial water damage to ceilings to the eastern shopfront  
Source: Urbis 2026

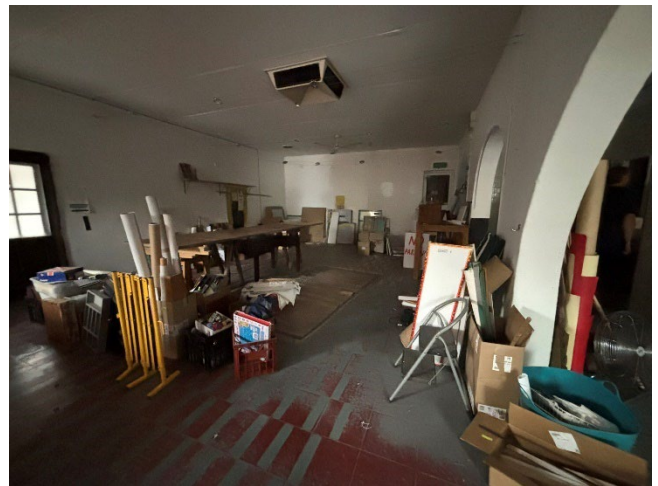
Figure 11 11 King William Street west shop front interior condition, no remnant heritage fabric remains internally  
Source: Urbis 2026

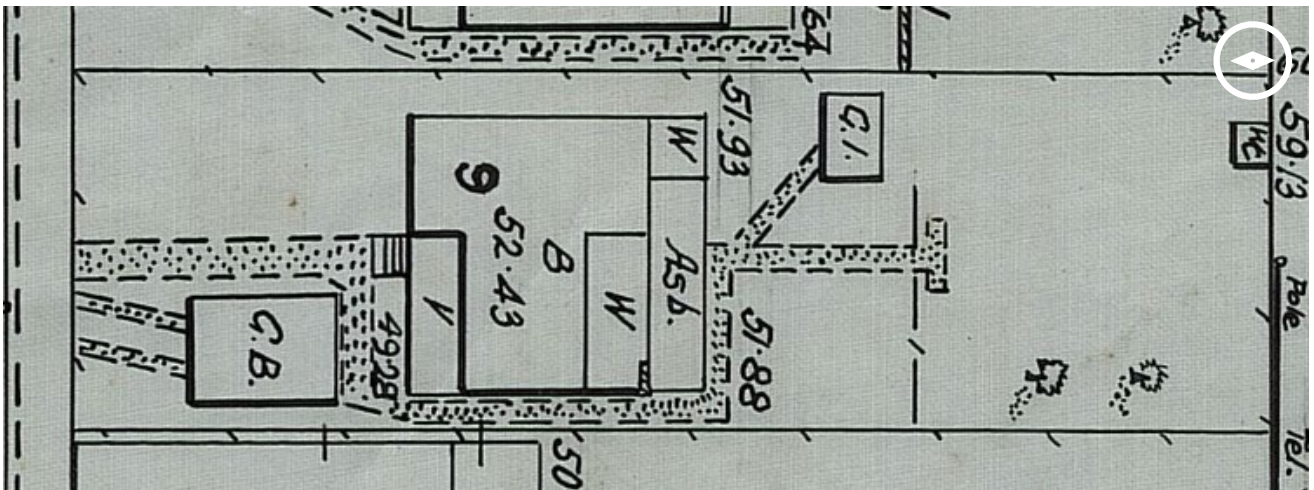
Figure 16 – Metro Map showing 9 King William Street, dated 1938.

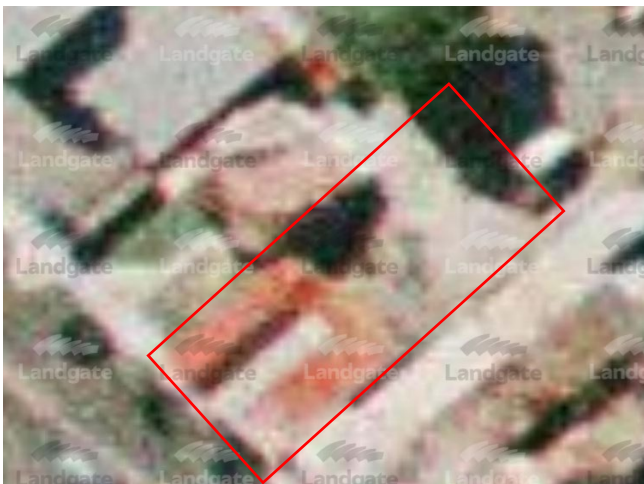
Figure 23 – Prior to roof replacement, dated 1983.  
 Source: Landgate Map Viewer Plus, <https://map-viewer-plus.app.landgate.wa.gov.au/index.html>

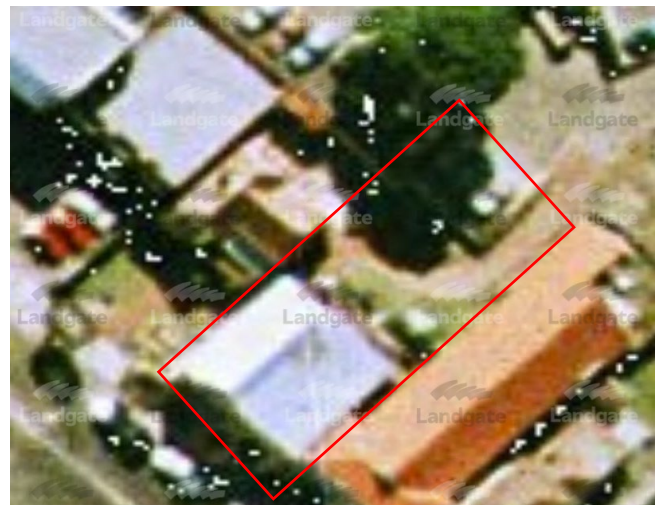
Figure 24 – After roof replacement, dated 1985.  
 Source: Landgate Map Viewer Plus, <https://map-viewer-plus.app.landgate.wa.gov.au/index.html>

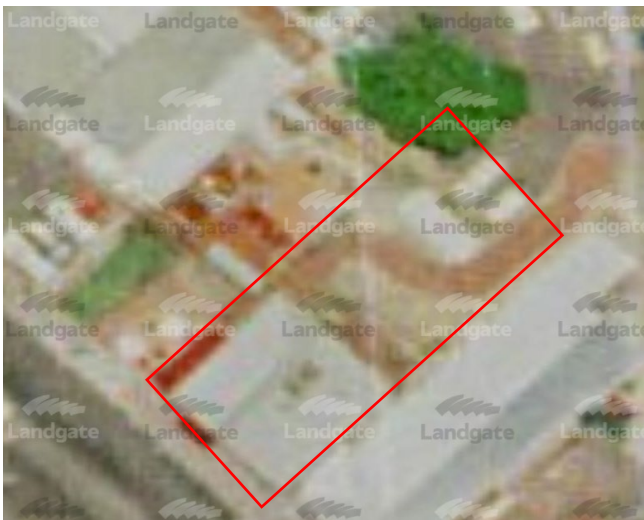
Figure 25 – Prior to the construction of the outdoor seating area, dated 1995. At this time a small red awning was added to the shopfront.  
 Source: Landgate Map Viewer Plus, <https://map-viewer-plus.app.landgate.wa.gov.au/index.html>
